1993, Ocean, 53 Super Sport

Report of Marine Survey

Conducted by
Steve Snider-AMS

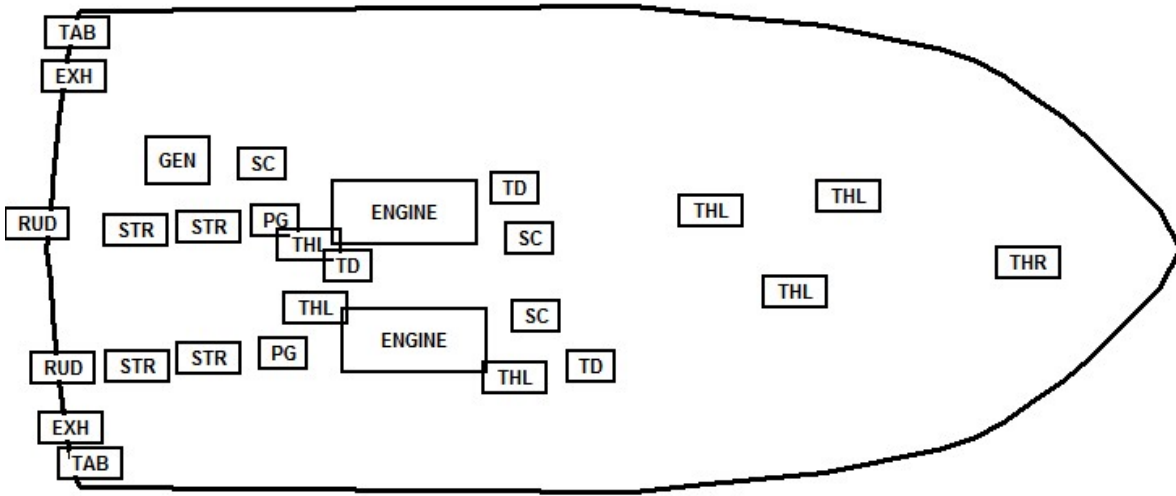
THRU-HULLS BELOW WATER LINE (DIAGRAM):

* **NOTE:** [B14] The below the water line thru-hull valves on this vessel were ball valve type and were NOT all operable. Two (2) seacocks would not close. Some of the below the water-line thru-hulls/seacocks show corrosion. One (1) thru-hull is plugged off and does not have a hose clamp. Service ALL below the water-line thru-hulls/seacocks/hoses/clamps using accepted marine practices.

This surveyor recommends that a vessel of this age if service documentation of recent thru-hull service cannot be provided have all below the water-line thru-hulls closely inspected by removing the hose clamps and hoses from the below the water-line thru-hulls and inspecting the internal condition of the thru-hull. ABYC (American Yacht and Boat Council) recommends in section H-27.6 Figure 1 a seacock static load test of 500 lbs.

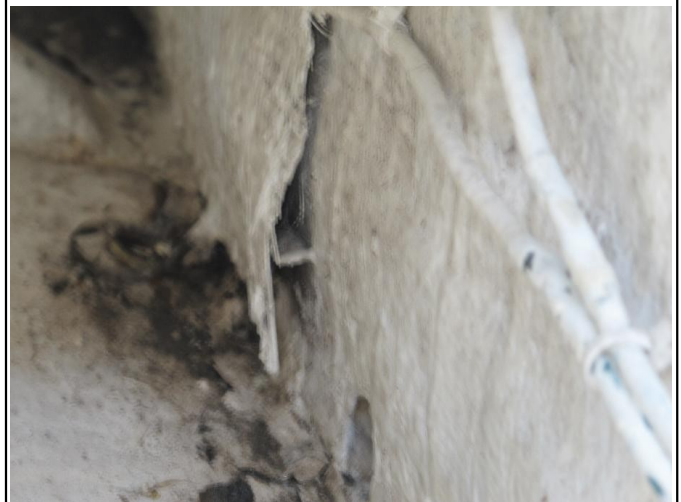
B.2 (PAGE 4) STRINGERS: There was fiberglass tabbing delamination sighted at the aft port stringer.	<i>Further investigate and repair with like kind materials in keeping with accepted marine repair practices.</i>
B.3 (PAGE 4) OTHER: The port rudder fasteners show corrosion and are weeping a brown fluid.	<i>Investigate further. Repair or replace fasteners as necessary.</i>

Fiberglass delamination aft port stringer

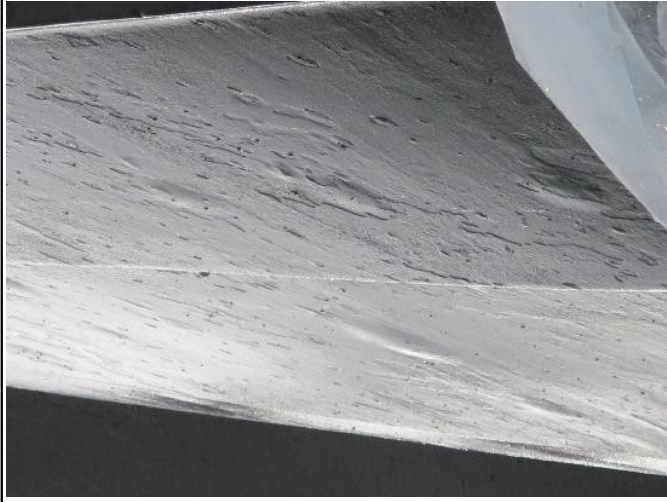
- * **BLISTERS:** [B20] Large blisters 4"-6" in size sighted at various areas of the hull area as described in the hull section of the body of the report.
- * **CONDITION OF BOTTOM PAINT:** [B21] Bottom paint is peeling in various areas.

Hull blisters

Investigate further to determine the scope of blister repair using destructive testing. Repair hull blisters using accepted marine practices.

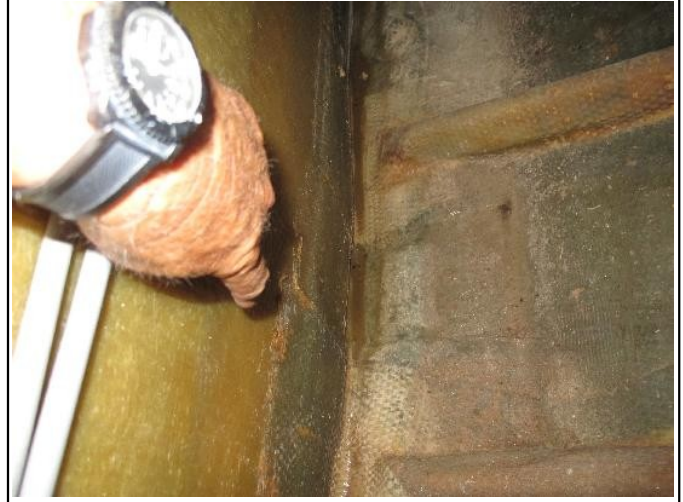
Fiberglass repair tacky at stringer under port stateroom floor

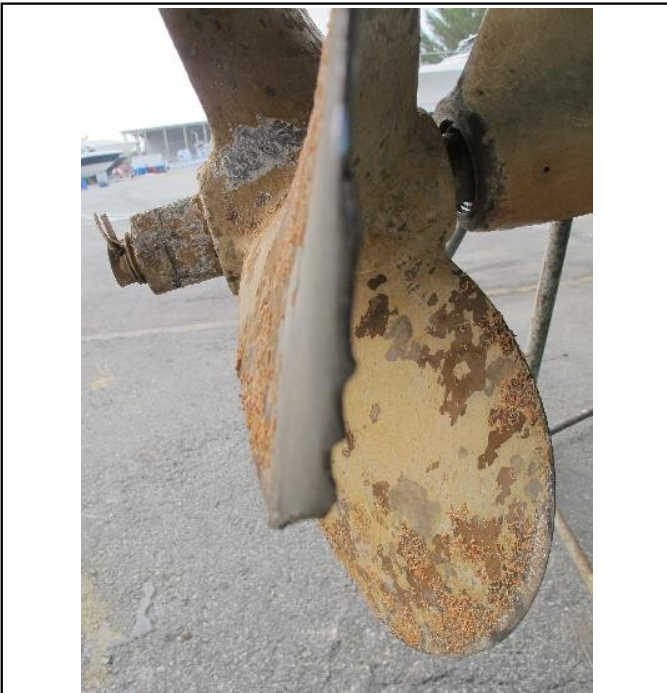
Two (2) bronze alloy, four bladed propellers. 28 X 31P. The starboard propeller was loose and tightened during this haul-out. Both propellers have blades damaged (bent at ends) and require service.

Props are damaged

Repair propellers using accepted marine practices.
