1993, Ocean, 53 Super Sport

Report of Marine Survey

Conducted by
Steve Snider-AMS

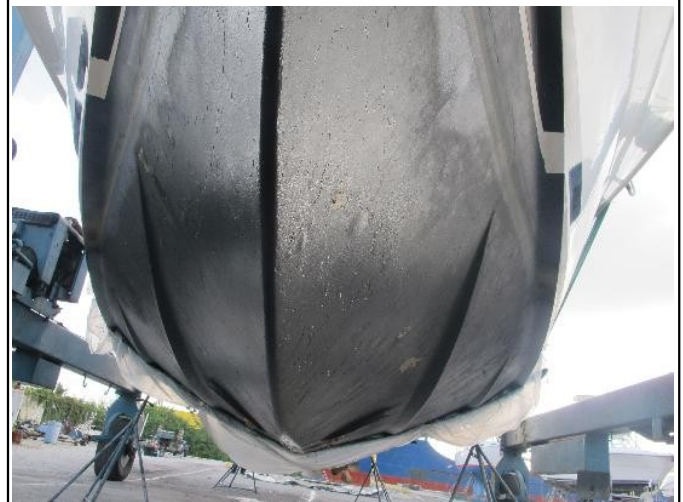
Hull view

- * **EXTERIOR HULL:** [B1] Black bottom paint with white hull sides. The hull sides appear to have been recently compounded and waxed. Good cosmetic appearance. The exterior hull shows large blisters scattered on the hull port and starboard. Inside the cabin area at the forward stateroom on the starboard side below the closet the fabric covering the wall was loose and it appears that fiberglass repairs have been made at the inside of the hull in this area. There was also fiberglass repairs below the port stateroom floor hatch where the fiberglass resin was tacky to the touch. The port stateroom outboard cabinet also shows evidence of fiberglass repairs. Moisture meter readings were sighted to be high at various areas of the hull. Sounding the hull with a phenolic hammer produced a negative (dull) sound at the forward starboard hull area.

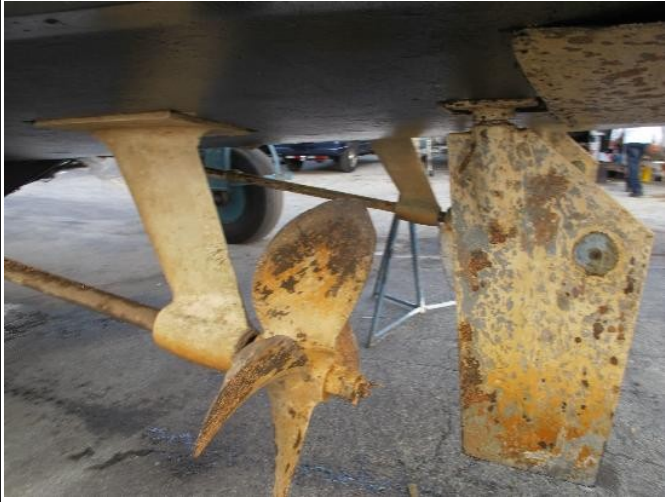
Running gear

- * **OTHER:** [B3] The port rudder fasteners show corrosion and are weeping a brown fluid.
- * **NOTE:** [B4] The aft swim platform shows minor fiberglass and gelcoat damage at the center aft platform area.
